Measurement of Vibration on The Alternator Due to The Influence of Rotation Speed

Abstract. The alternator or dynamo ampere is a device that functions as a generator that produces alternating current (AC) and converts it to direct current (DC). Signs of damage that often occur due to damage to the Alternator are the smell of burning, squeaking, dim spotlights, indicator lights, malfunction of the battery, and the supply of electricity. These signs will cause the vehicle to stop in the middle of the trip the electricity supply is very lacking. This requires that preventive maintenance checks on the alternator are a must in the automotive world. In this paper we research measuring the vibration of the alternator due to the influence of rotation speed (750 rpm and 1800 rpm), to predict damage to the alternator of the Daihatsu Luxio vehicle. The results of this study indicate that at the rotational speed of 750 rpm and 1800 rpm, were found 1x rpm the condition of the vibration amplitude on the alternator is smaller than the alternator in poor condition, this is due to the presence of an unbalanced alternator. Also, vibration due to misalignment is obtained because it has characteristi

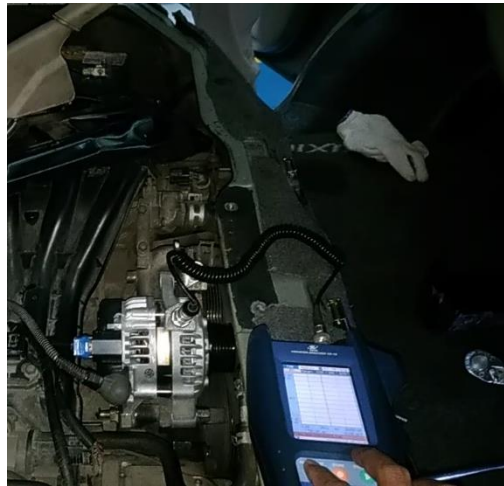
Figure 1. Alternator Daihatsu Luxio

The alternator or dynamo ampere is a device that functions as a generator that produces alternating current (AC) and converts it to direct current (DC). This component also generates electrical energy which is filled in the battery, as shown in Figure 1. The charging system has 3 important components, namely the Accumulator, Alternator, and Regulator. This alternator functions together with the Accumulator to generate electricity when the engine is turned on. The result produced by the alternator is an AC voltage which is then converted into DC voltage. As a power generator, it utilizes the rotation of the engine, therefore the alternator requires a belt or belt. The belt functions to distribute the rotational motion of the car engine to rotate the alternator, this rotation is used by the alternator to generate electrical energy. In operation, the components inside the alternator move in rotation with a certain rotation. When the components move, there are forces of inertia and forces that come from the power transmission process. These forces will cause the component structure on the alternator to vibrate. In a well-designed alternator, the resulting vibration is lower, but if a long period of use will cause the amplitude of the vibration to be large, this will affect the condition of the components inside. The resulting vibration signal will have a spectrum frequency and certain vibrational characteristics. The effect of the vibrations that appear on the alternator components has a very large effect, which in turn will cause a harsh sound to appear.

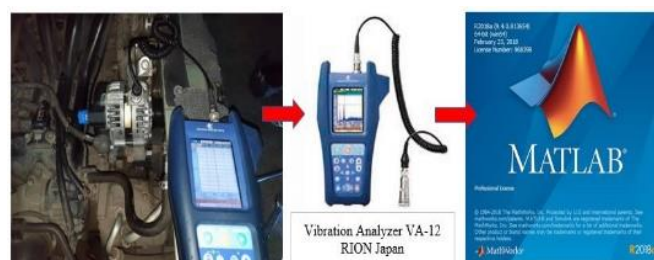
Figure 3. Set-up vibration measurement

The frequency range used in this study is 1 - 1000 Hz, where the data collection and processing procedures can be seen in Figure 3. The data obtained from the measurement results are then analyzed using Matlab. The equipment used in the collection of vibration measurement data is as follows:

- The accelerometer, which is used is a piezoelectric accelerometer made by Rion Japan Corporation type CCLD type, PV-571. Accelerometer functions to measure vibration response.
- Frequency span 100 Hz with line analysis 1600 using linear function window.
- Actual Sensitivity Num 510 and actual sensitivity magnify x0.01.

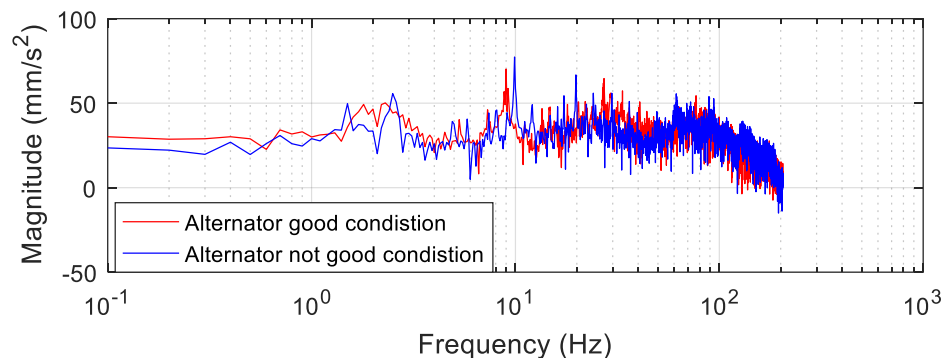
(a) Fast Fourier Transform Analysis

(b) PSD Analysis

Figure 5. Vibration analysis with a rotation speed of 1800 rpm at point E

At the rotation speed of 1800 rpm, the noise produced is lower than the rotation speed of 750 rpm. This shows that the faster the alternator rotation can reduce the resulting noise. The damage due to misalignment and imbalance in the alternator is obvious. This is because the resonance that occurs is reduced with less noise. At the rotating speed of 1800 rpm, an imbalance occurs in the rotor. Rotor imbalance can be interpreted as an unbalanced mass distribution at the center of rotation of the rotor and this is the most common problem in alternators, where vibrations with a frequency of 1xRPM and/or accompanied by a relatively large 2xRPM. Also, at 1800 rpm the alternator experienced shaft misalignment. Shaft misalignment is the most common cause of alternator due to

vibration after imbalance, which causes an increase in dynamic load and accelerates the breakdown of the alternator wherein the misalignment provides fundamental harmonics at 2x rpm, as shown in Figure 5(a).

In Figure 5, it is shown that the damaged alternator has experienced a frequency shift from the alternator in good condition. Also, the emergence of new frequencies is generated in certain states and stages of deterioration, where the spectral data shows the sub-harmonic multiplication of 1 / 2xRPM.
